Manhole Inspection Summary

Manhole # S31CC_057MH

Insp Date: **2/6/07 10:26 AM**

Location Address: **EUTAW ST**

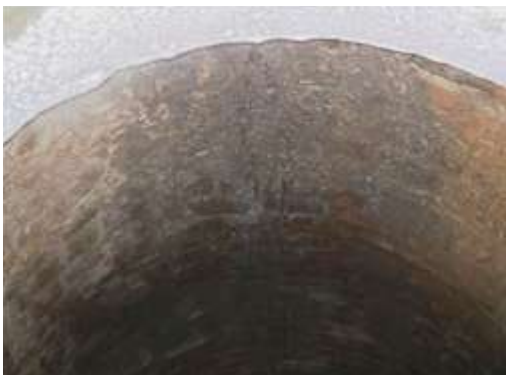
Defect

Frame Offset: **0** (in.) Condition: ☐ Sound ☐ Cracked ☒ **Leaks**

Infiltration: ☐ None ☒ **Joint** ☐ Cracks ☐ Mortar ☐ Roots ☒ **Wall**

Frame leaks. Adjustment infiltration.
